Conway Branch Railroad Line Feasibility Study

**Report to the New Hampshire Legislature
Chapter 298:4, Laws of 2003**

June 30, 2004

Department of Transportation
Bureau of Rail & Transit
7 Hazen Drive
Concord, NH 03302

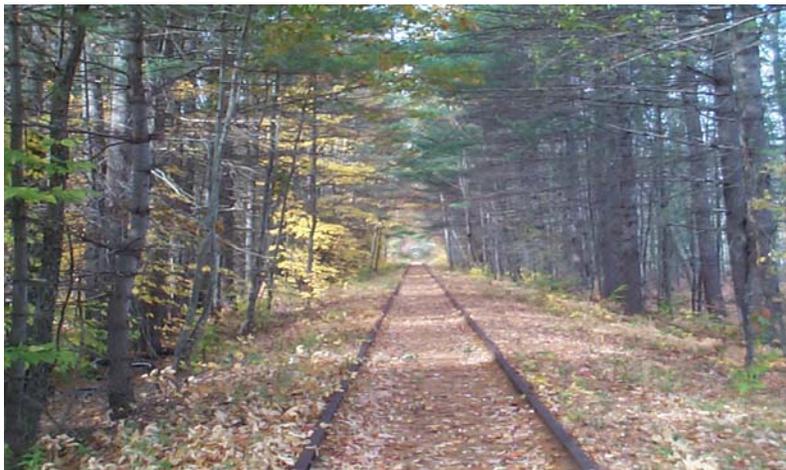
The brush and trees along the railroad line have been cut back to just off the end of the ties by the Department of Resources and Economic Development's Trails Bureau over the last few years. While this has kept the brush and trees from covering the rail, additional clearing would be required on almost all of the railroad corridor to provide adequate clearances to run trains and to remove the tree canopy over the tracks. The trees and brush should be cut back a minimum of 12' from the nearest rail to ensure adequate clearance for the train and railroad workers walking

Fig. 1: Tree growth on Conway Branch corridor

beside the train. Additional trees should be cut or limbed to remove the canopy over the tracks so the sun can keep the track structure dried out, thus extending its life span. The estimated cost to clear the 22- mile railroad corridor is \$60,000.

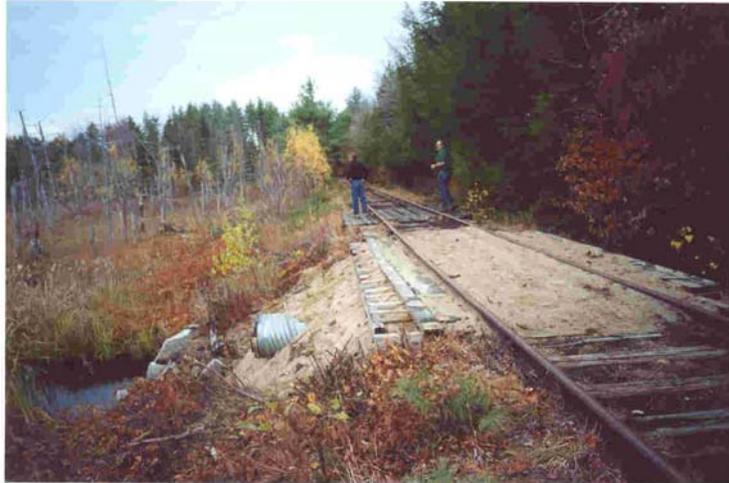
The drainage on this segment of the line includes approximately 10 pipe culverts and 32 stone box culverts. The drainage structures are generally in good condition, except that six stone culverts require repairs because some of the slabs have shifted. The large stone box culvert at MP 126.45 has several collapsed slabs on the west side inlet caused by a backhoe that dislodged

Fig. 2: Temporary culvert replacement

them while cleaning out a beaver dam. These slabs should be repaired so the culvert will flow properly. Beaver dams need to be removed from the inlets of several culverts so they will operate properly and not wash out additional sections of the tracks. The estimated cost to repair the damaged stone box culverts and open up the inlets of the drainage structures with excavating equipment is \$25,000.

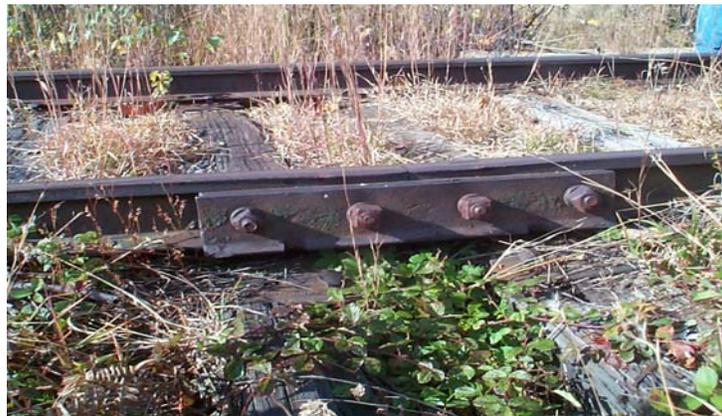
The tie condition on the entire corridor is fair to poor. Some tie replacement work appears to have been done in the early 1970s, but this sparse and minimal effort addressed only limited locations. The areas of poor or failed drainage, aggravated by vegetation shading, have taken a toll on ties of 1940s vintage and older. Replacement of an average of 1,000 ties per mile would be required to begin Class I railroad operations. There are 30 curves in the corridor (none greater than 3°), where more new ties would be needed than on tangent (straight) sections in order to absorb forces from train movements. The corridor does have an unusually large amount of tangent track with many nearly mile long straight sections approaching and following curves. With lighter weight rail, a higher percentage of new ties is needed to provide stability of track structure. More new ties are also needed in wet areas that need complete reconstruction; it is more difficult to insert ties singly in these areas. The cost to install sufficient ties to begin Class I railroad operation is estimated to be \$1,280,000 (Phase 1). The cost to install sufficient ties for Class II track is estimated to be an additional \$550,000 (Phase 2), which would be required within five years of operation commencing.

Fig. 3: Vegetation growth and poor tie condition

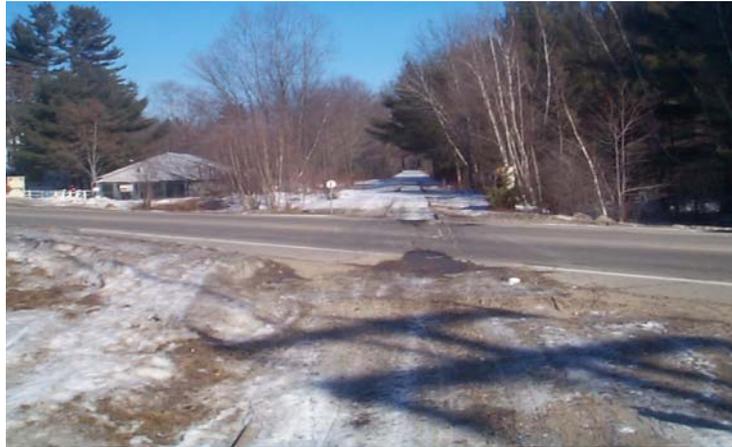
Fig. 4: Route 16 crossing, Ossipee

All of the public road crossings would need to be totally reconstructed because rail and ties under the pavement are probably in poor condition (in some cases the rail has been removed). New crossing protection consisting of signs and in some cases flashing signals would need to be installed at all public crossings. New welded 115 lb. rail would be required in the crossings to meet current State standards. The five state road crossings would require automatic flashing lights and signage (crossbucks and advance warning signs). The cost of installing the rail, ballast, pavement, joint seal and signals at these crossings is estimated to be \$1,650,000. The eight town road crossings would require passive crossing protection at a minimum, with signage (crossbucks and advance warning signs). The cost of installing the rail, ballast, pavement, joint seal and signage at these crossings is estimated to be \$880,000. The residential and private crossings would also need to be reviewed and approved by the Department of Transportation, and reconstructed. The reconstruction cost is estimated to be a total of \$150,000, and should be paid by the landowners using the crossings. The remaining five illegal crossings should be removed unless they are reviewed and crossing agreements executed with the Department of Transportation.

to be removed from both locations and at-grade crossings constructed. The temporary gravel crossings over the railroad track at several other locations would also need to be removed or replaced with timber or paved crossings. The landowners with undocumented crossings need to execute crossing agreements with the Department of Transportation for the crossings to remain.

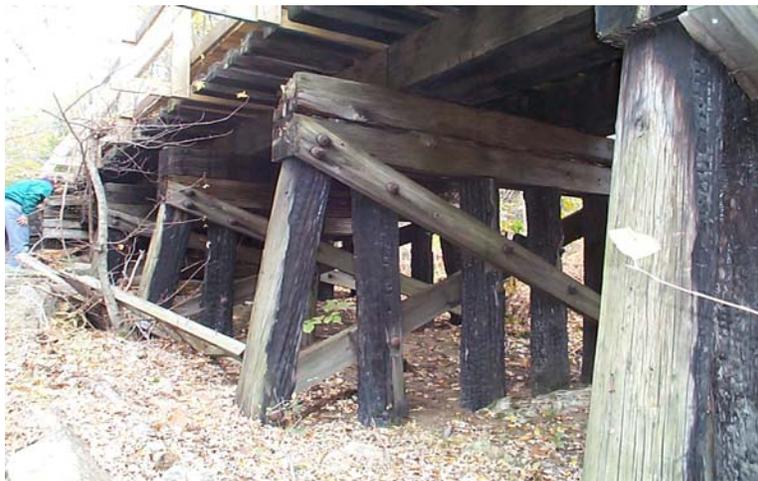
There are 15 bridges on this section of the Conway Branch railroad corridor. The bridge structures are mostly in good condition, with repairs required to some of the timber supports, deck timbers and concrete abutments or backwalls. Bridge problems include rotted deck timbers, rotted wood supports, cracked mortar in the granite block abutments, deteriorated concrete, and washouts around abutments on three of the bridges. A fire damaged the Bearcamp River overflow bridge in Ossipee last year, and it would require repair. A detailed list of bridges on the corridor including the necessary repairs and the anticipated cost required to repair each bridge is included in this report as Table 3.

Fig. 5: Bridge timbers

The bridge deck timbers supporting the rail would all need to be replaced in the first five years of railroad operation. Approximately 50% of the bridges would need new deck timbers before train service could be restored, and the other 50% would need to be replaced in the first 5 years of railroad operation. Once the bridge timbers are replaced, their expected life span should be 20-30 years. The total estimated repair cost for the bridges is \$477,000 (Phase 1) to begin operations, and another \$285,000 (Phase 2) within five years to complete repairs to additional bridge components not yet at the end of their useful life.
