Milton Road Surface Management System Report

This report was completed by the Town of Milton in collaboration with the Strafford Regional Planning Commission. Road Surface Management System assessments were completed in the town in July 2022, and the forecasting report was finalized in April 2023.

Town of Milton

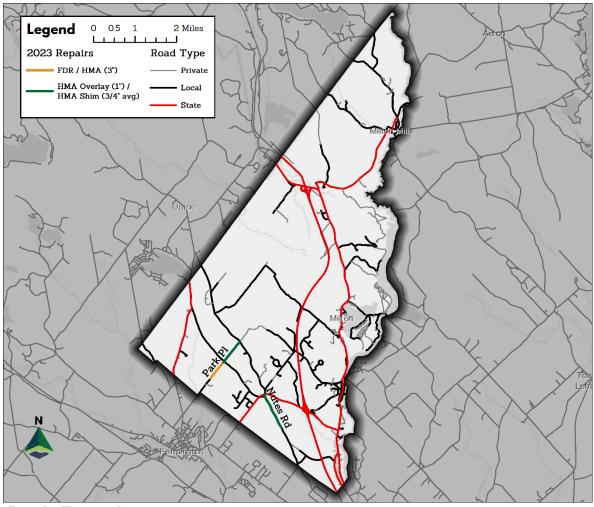
Average PCI After Repairs	69.09
Average PCI Without Repairs	66.82
Total Miles Treated	2.02
Total Repair Cost	\$367,344
FDR & HMA (3")	\$147,582
FDR & HMA (4")	\$0
HMA Overlay (1")	\$113,425

Roads Treated: Nutes Road, Park Place, Thurston Road

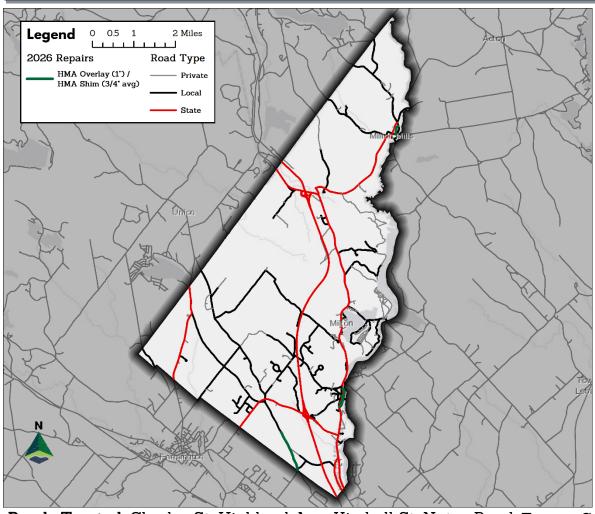
Average PCI After Repairs	64.42
Average PCI Without Repairs	58.21
Total Miles Treated	1.77
Total Repair Cost	\$284,443
HMA Overlay (1")	\$146,810
HMA Shim (3/4" avg)	\$137,634

Roads Treated: Charles St, Highland Ave, Kimball St, Nutes Road, Tappan Court

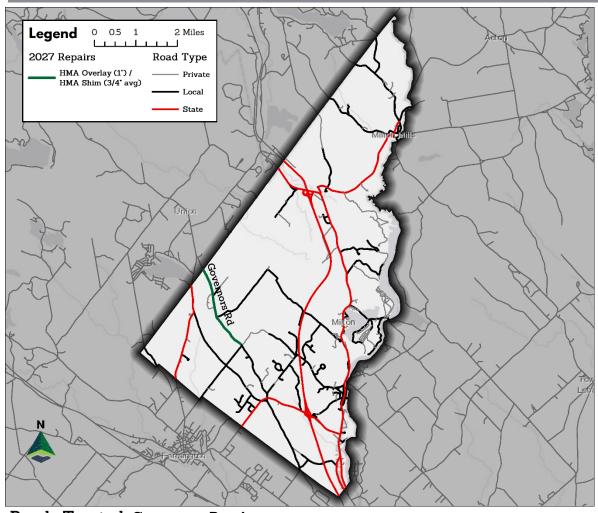
Average PCI After Repairs	62.86
Average PCI Without Repairs	55.6
Total Miles Treated	2.06
Total Repair Cost	\$322,190
HMA Overlay (1")	\$166,292
HMA Shim (3/4" avg)	\$155,898

Roads Treated: Governors Road

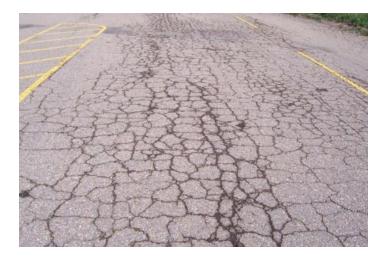
High Severity

Alligator cracking refers to interconnected crack patterns that resemble alligator skin or chicken wire. Pavement pieces range in size from one to six inches on a side.

No Defects	The road section has no visible signs of alligator cracking.
<u>Low</u>	Crack pattern is just beginning to appear. Cracks have no measureable width and no actual pavement separation is found.
<u>Medium</u>	Easily discernible cracking with measureable crack <i>widths</i> up to 1/8" and some breakup. Pavement pieces, while loose, are still interconnected.
<u>High</u>	Wide cracking (1/4") has resulted in major pavement breakup with loose pieces actually displaced.

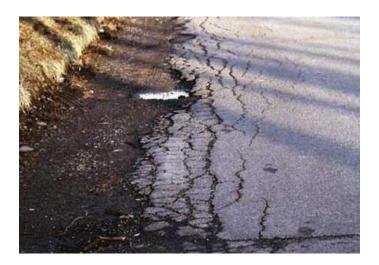
High Severity

Edge cracking refers to cracks adjacent and/or parallel to the edge of the pavement. While generally confined to the outer one or two feet of pavement, edge cracking can progress into the travel lane.

No Defects	The roadway does not exhibit edge cracking.
<u>Low</u>	Cracking evident; however, no breakup. Crack widths <1/8" and confined to 12" from <i>edge of pavement</i> .
<u>Medium</u>	Multiple cracking occurring with some breakup. Cracks extend up to 24" into pavement.
<u>High</u>	Extensive cracking beyond 24" into roadway; breakup. This condition closely resembles alligator cracking

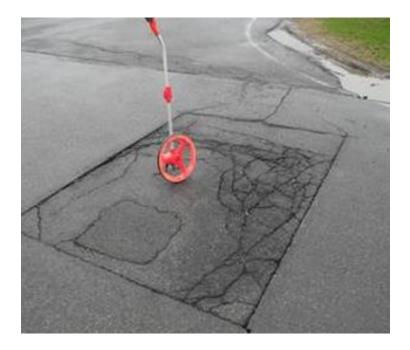
Patching refers to areas where the original pavement has been removed and subsequently replaced but is showing deterioration. Potholes are areas where portions of the road pavement have broken and loss of pavement has resulted in a bowl-shaped depression.

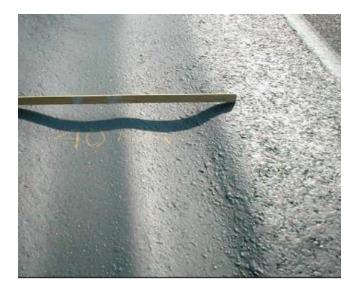
High Severity

Rutting refers to the channel depressions in the wheel paths. Rutting causes water to drain along the road surface rather than drain to the edge of the road.

1. Ruts are caused by a permanent deformation in any of the road layers or subgrade. Ruts result from repeated vehicle passes when the road is soft. Significant rutting can destroy a road.

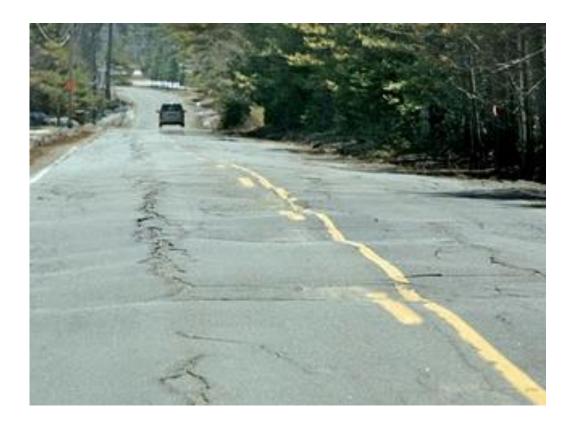
Frost Heave

<u>None</u>	Interview with local knowledge does not identify this road segment as being prone to frost heaves.
<u>Low</u>	Interview with local knowledge indicates that this segment is prone to minor frost heave severity, but does not affect vehicle travel.
<u>Medium</u>	Interview with local knowledge indicates that this segment is prone to substantial frost heave severity and is just beginning to affect vehicle travel.
<u>Severe</u>	Interview with local knowledge indicates that this segment is prone to major frost heave severity and clearly affects vehicle travel.
