Newmarket Road Surface Management System Report

This report was completed by the Town of Newmarket in collaboration with the Strafford Regional Planning Commission. Road Surface Management System assessments were completed in the town in November 2022, and the forecasting report was finalized in May 2023.

The Road Surface Management System

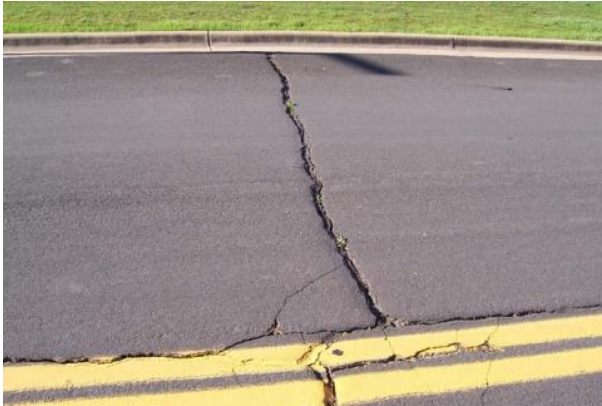
High Well-defined cracks filled with foreign material (sand, stones, etc.)
Extensive spalling and breakage

High Severity

Transverse Crack

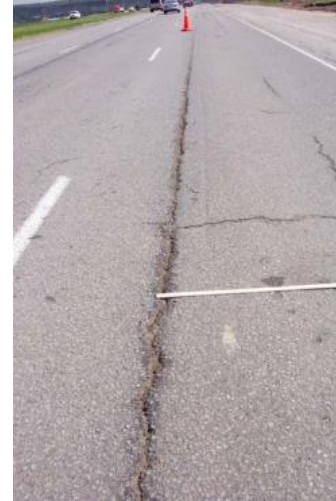
Longitudinal Crack

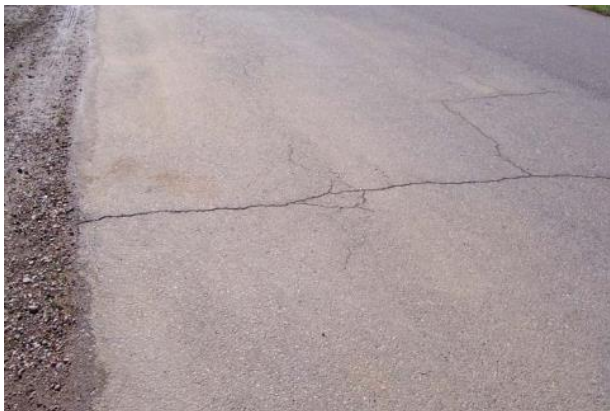
Medium Crack widths up to 1/4" in width with some spalling evident (width of pencil)

Medium Severity

Transverse Crack

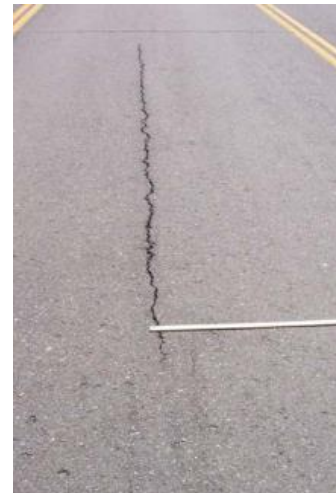
Longitudinal Crack

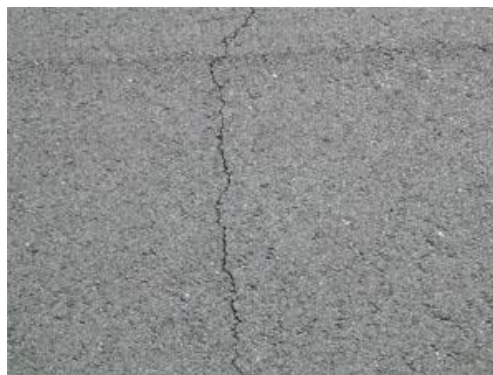
Low Hairline cracks with little or no spalling (width of pencil tip)

Low Severity

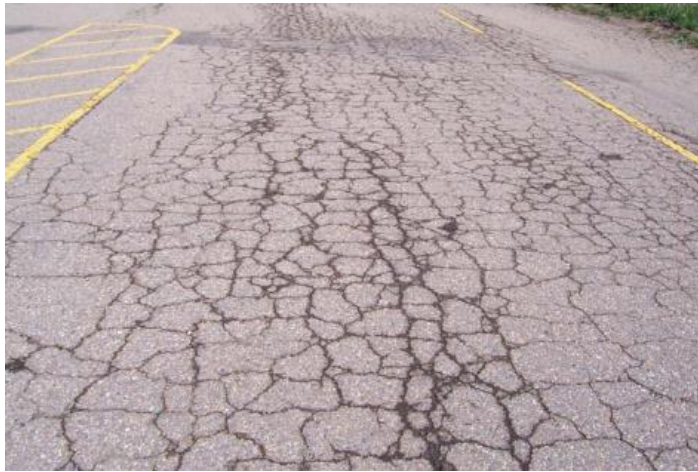
Alligator cracking refers to interconnected crack patterns that resemble alligator skin or chicken wire. Pavement pieces range in size from one to six inches on a side.

<u>No Defects</u>	The road section has no visible signs of alligator cracking.
<u>Low</u>	Crack pattern is just beginning to appear. Cracks have no measureable <i>width</i> and no actual pavement separation is found.
<u>Medium</u>	Easily discernible cracking with measureable crack <i>widths</i> up to 1/8" and some breakup. Pavement pieces, while loose, are still interconnected.
<u>High</u>	Wide cracking (1/4") has resulted in major pavement breakup with loose pieces actually displaced.

High Severity

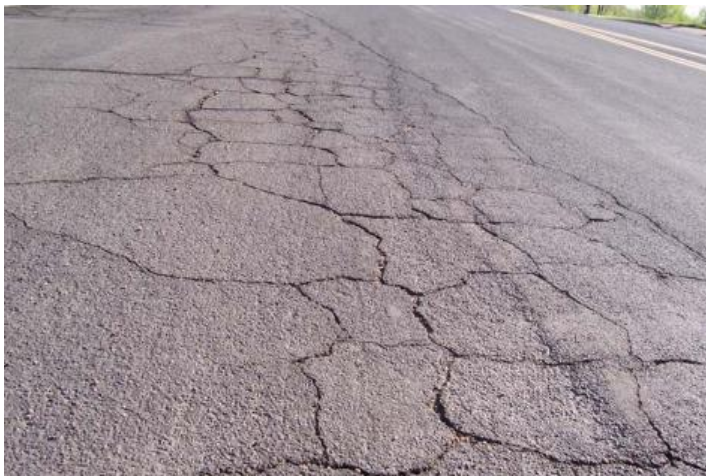
Medium Severity

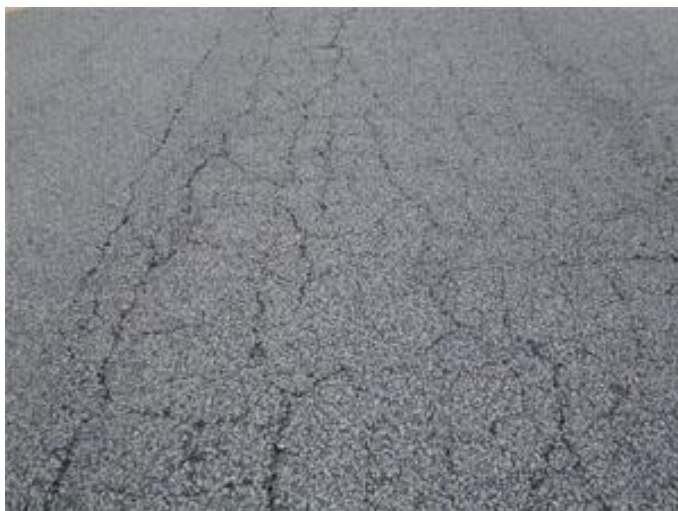
Low Severity

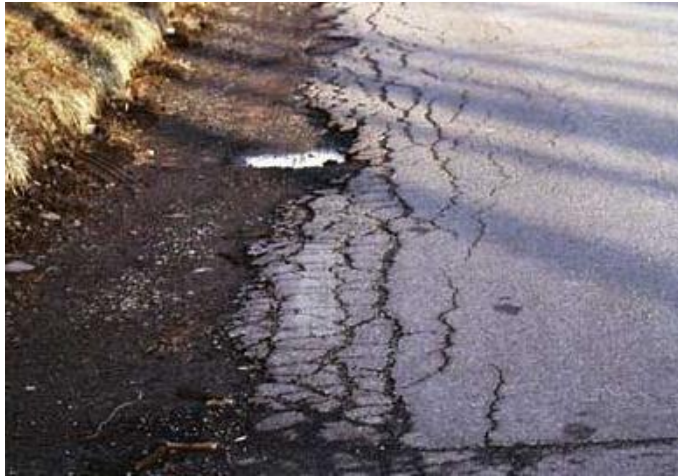
Edge cracking refers to cracks adjacent and/or parallel to the edge of the pavement. While generally confined to the outer one or two feet of pavement, edge cracking can progress into the travel lane.

<u>No Defects</u>	The roadway does not exhibit edge cracking.
<u>Low</u>	Cracking evident; however, no breakup. Crack widths <1/8" and confined to 12" from <i>edge of pavement</i> .
<u>Medium</u>	Multiple cracking occurring with some breakup. Cracks extend <i>up to 24" into pavement</i> .
<u>High</u>	Extensive cracking <i>beyond 24" into roadway</i> ; breakup. This condition closely resembles alligator cracking

High Severity

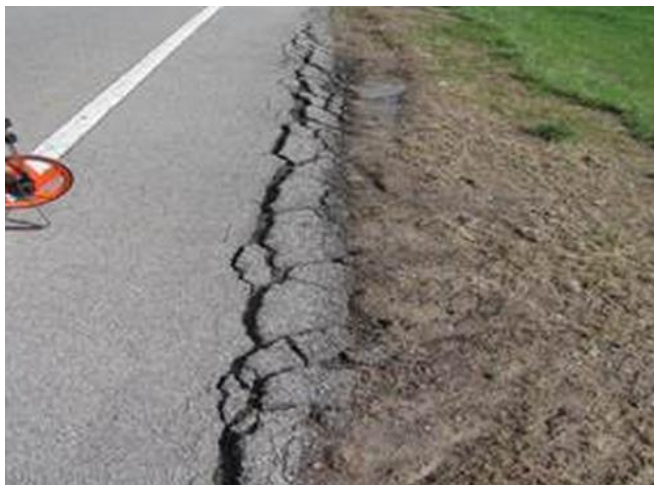
Medium Severity

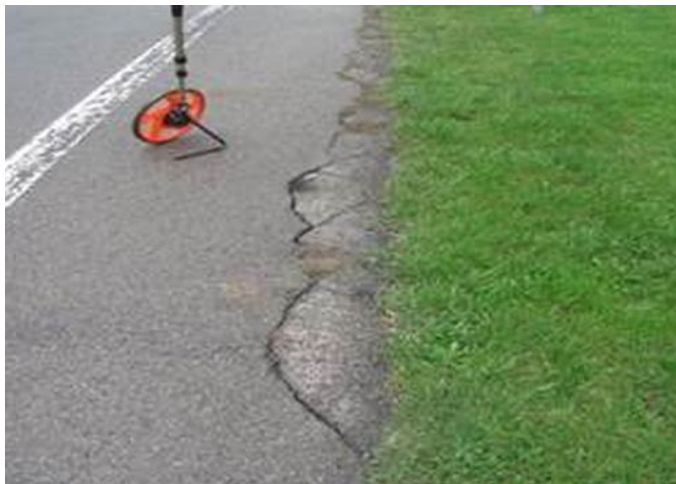
Low Severity

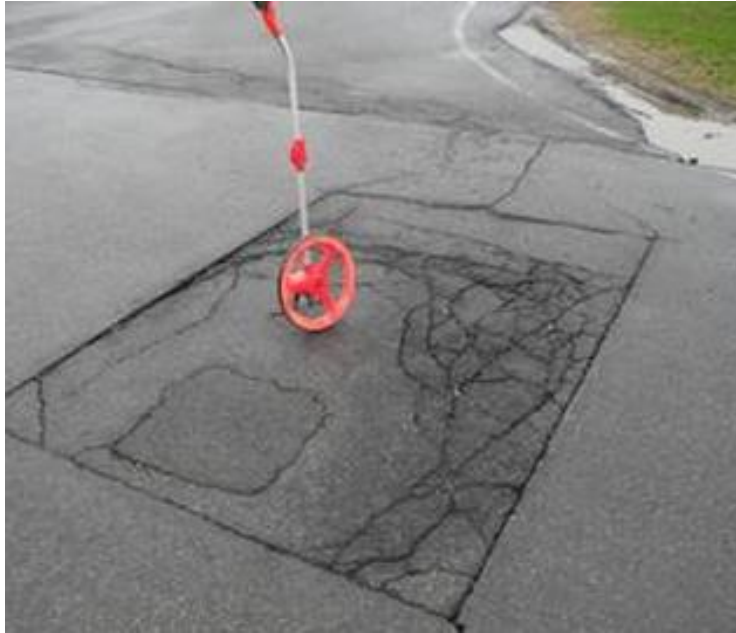
Patching refers to areas where the original pavement has been removed and subsequently replaced but is showing deterioration. Potholes are areas where portions of the road pavement have broken and loss of pavement has resulted in a bowl-shaped depression.

Patching

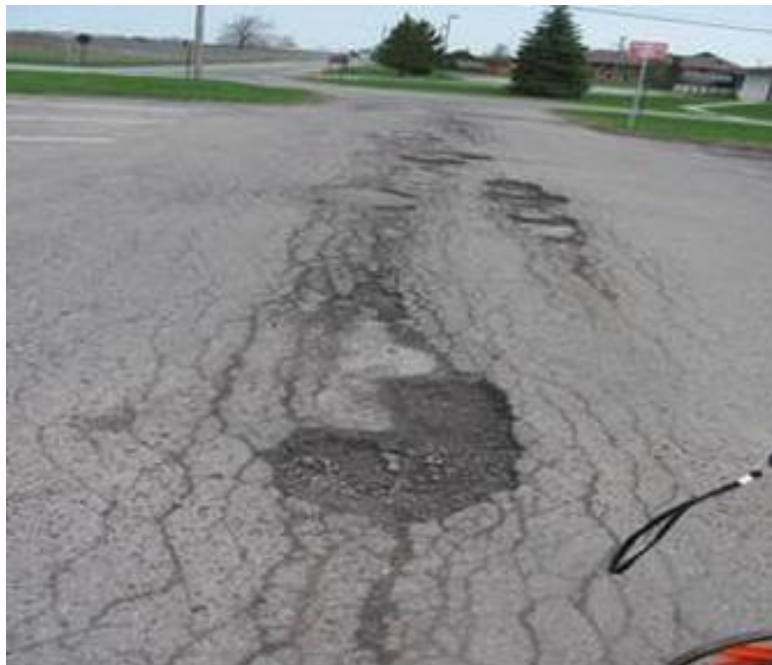
Pothole

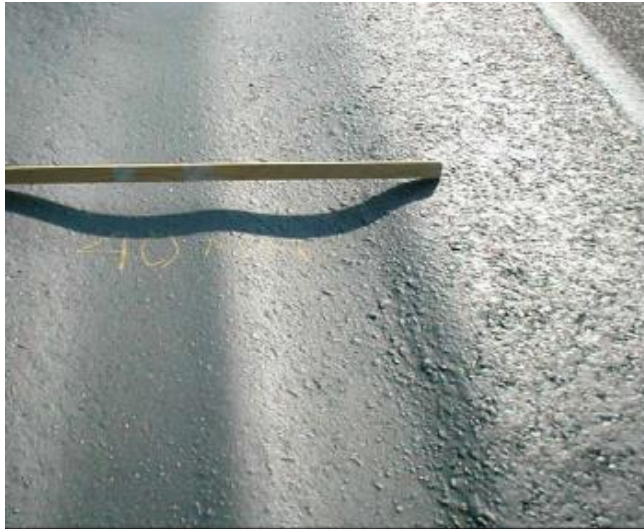
Rutting refers to the channel depressions in the wheel paths. Rutting causes water to drain along the road surface rather than drain to the edge of the road.

High Severity

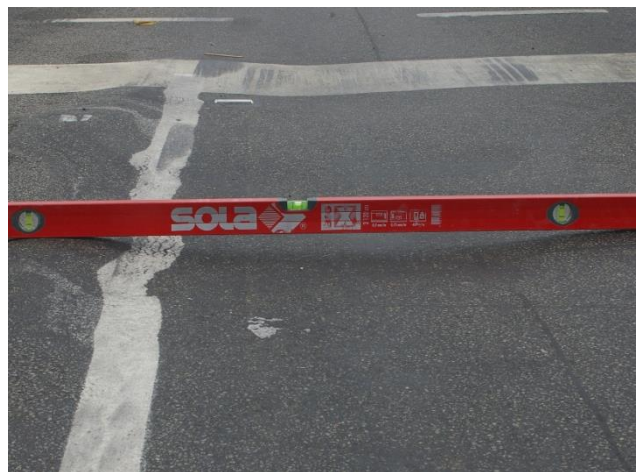
Medium Severity

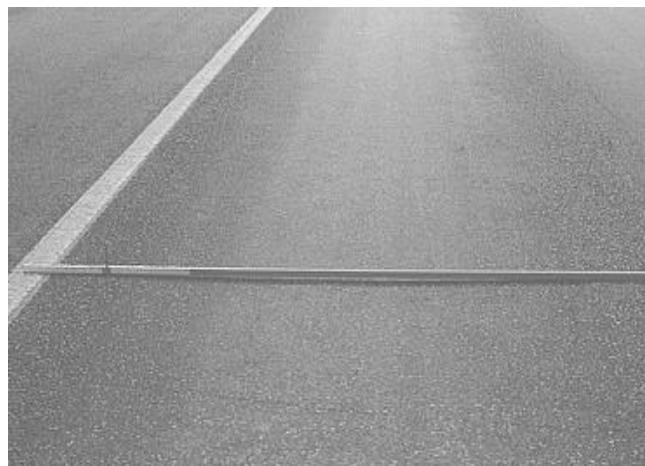
Low Severity

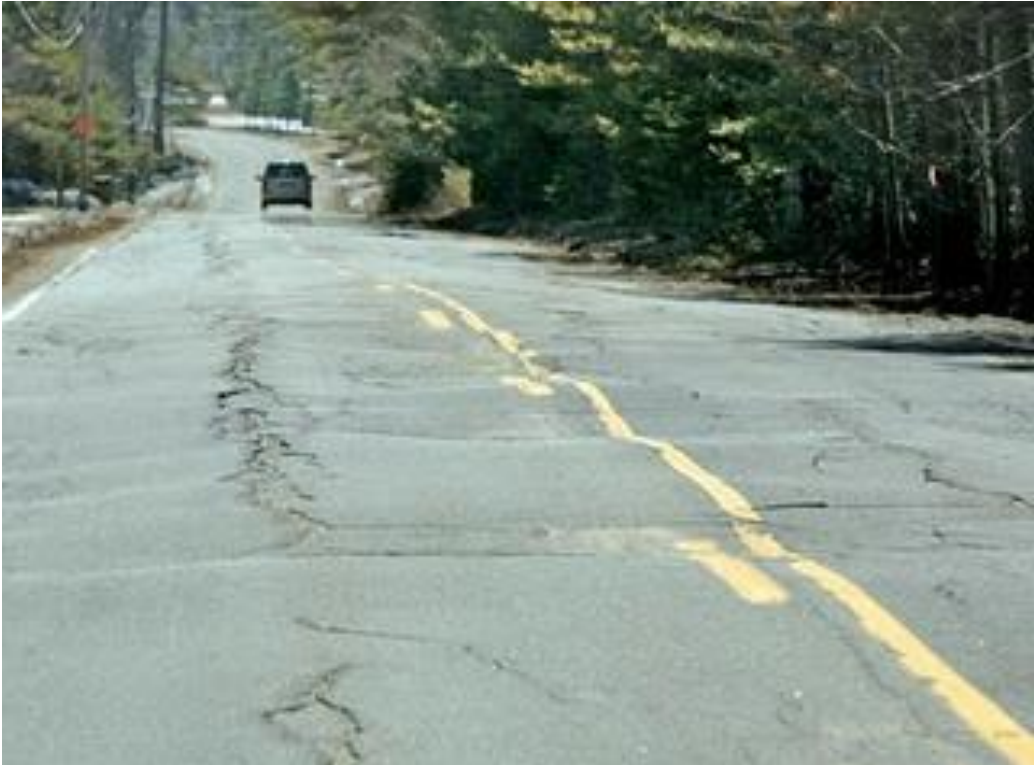
Frost Heave
